# BRIDGE FAILURE AND CONSEQUENCES: THE EXISTING INFRASTRUCTURES NEED OF MITIGATION TECHNIQUES

EGU24-19535

## 1. BRIDGE FAILURE

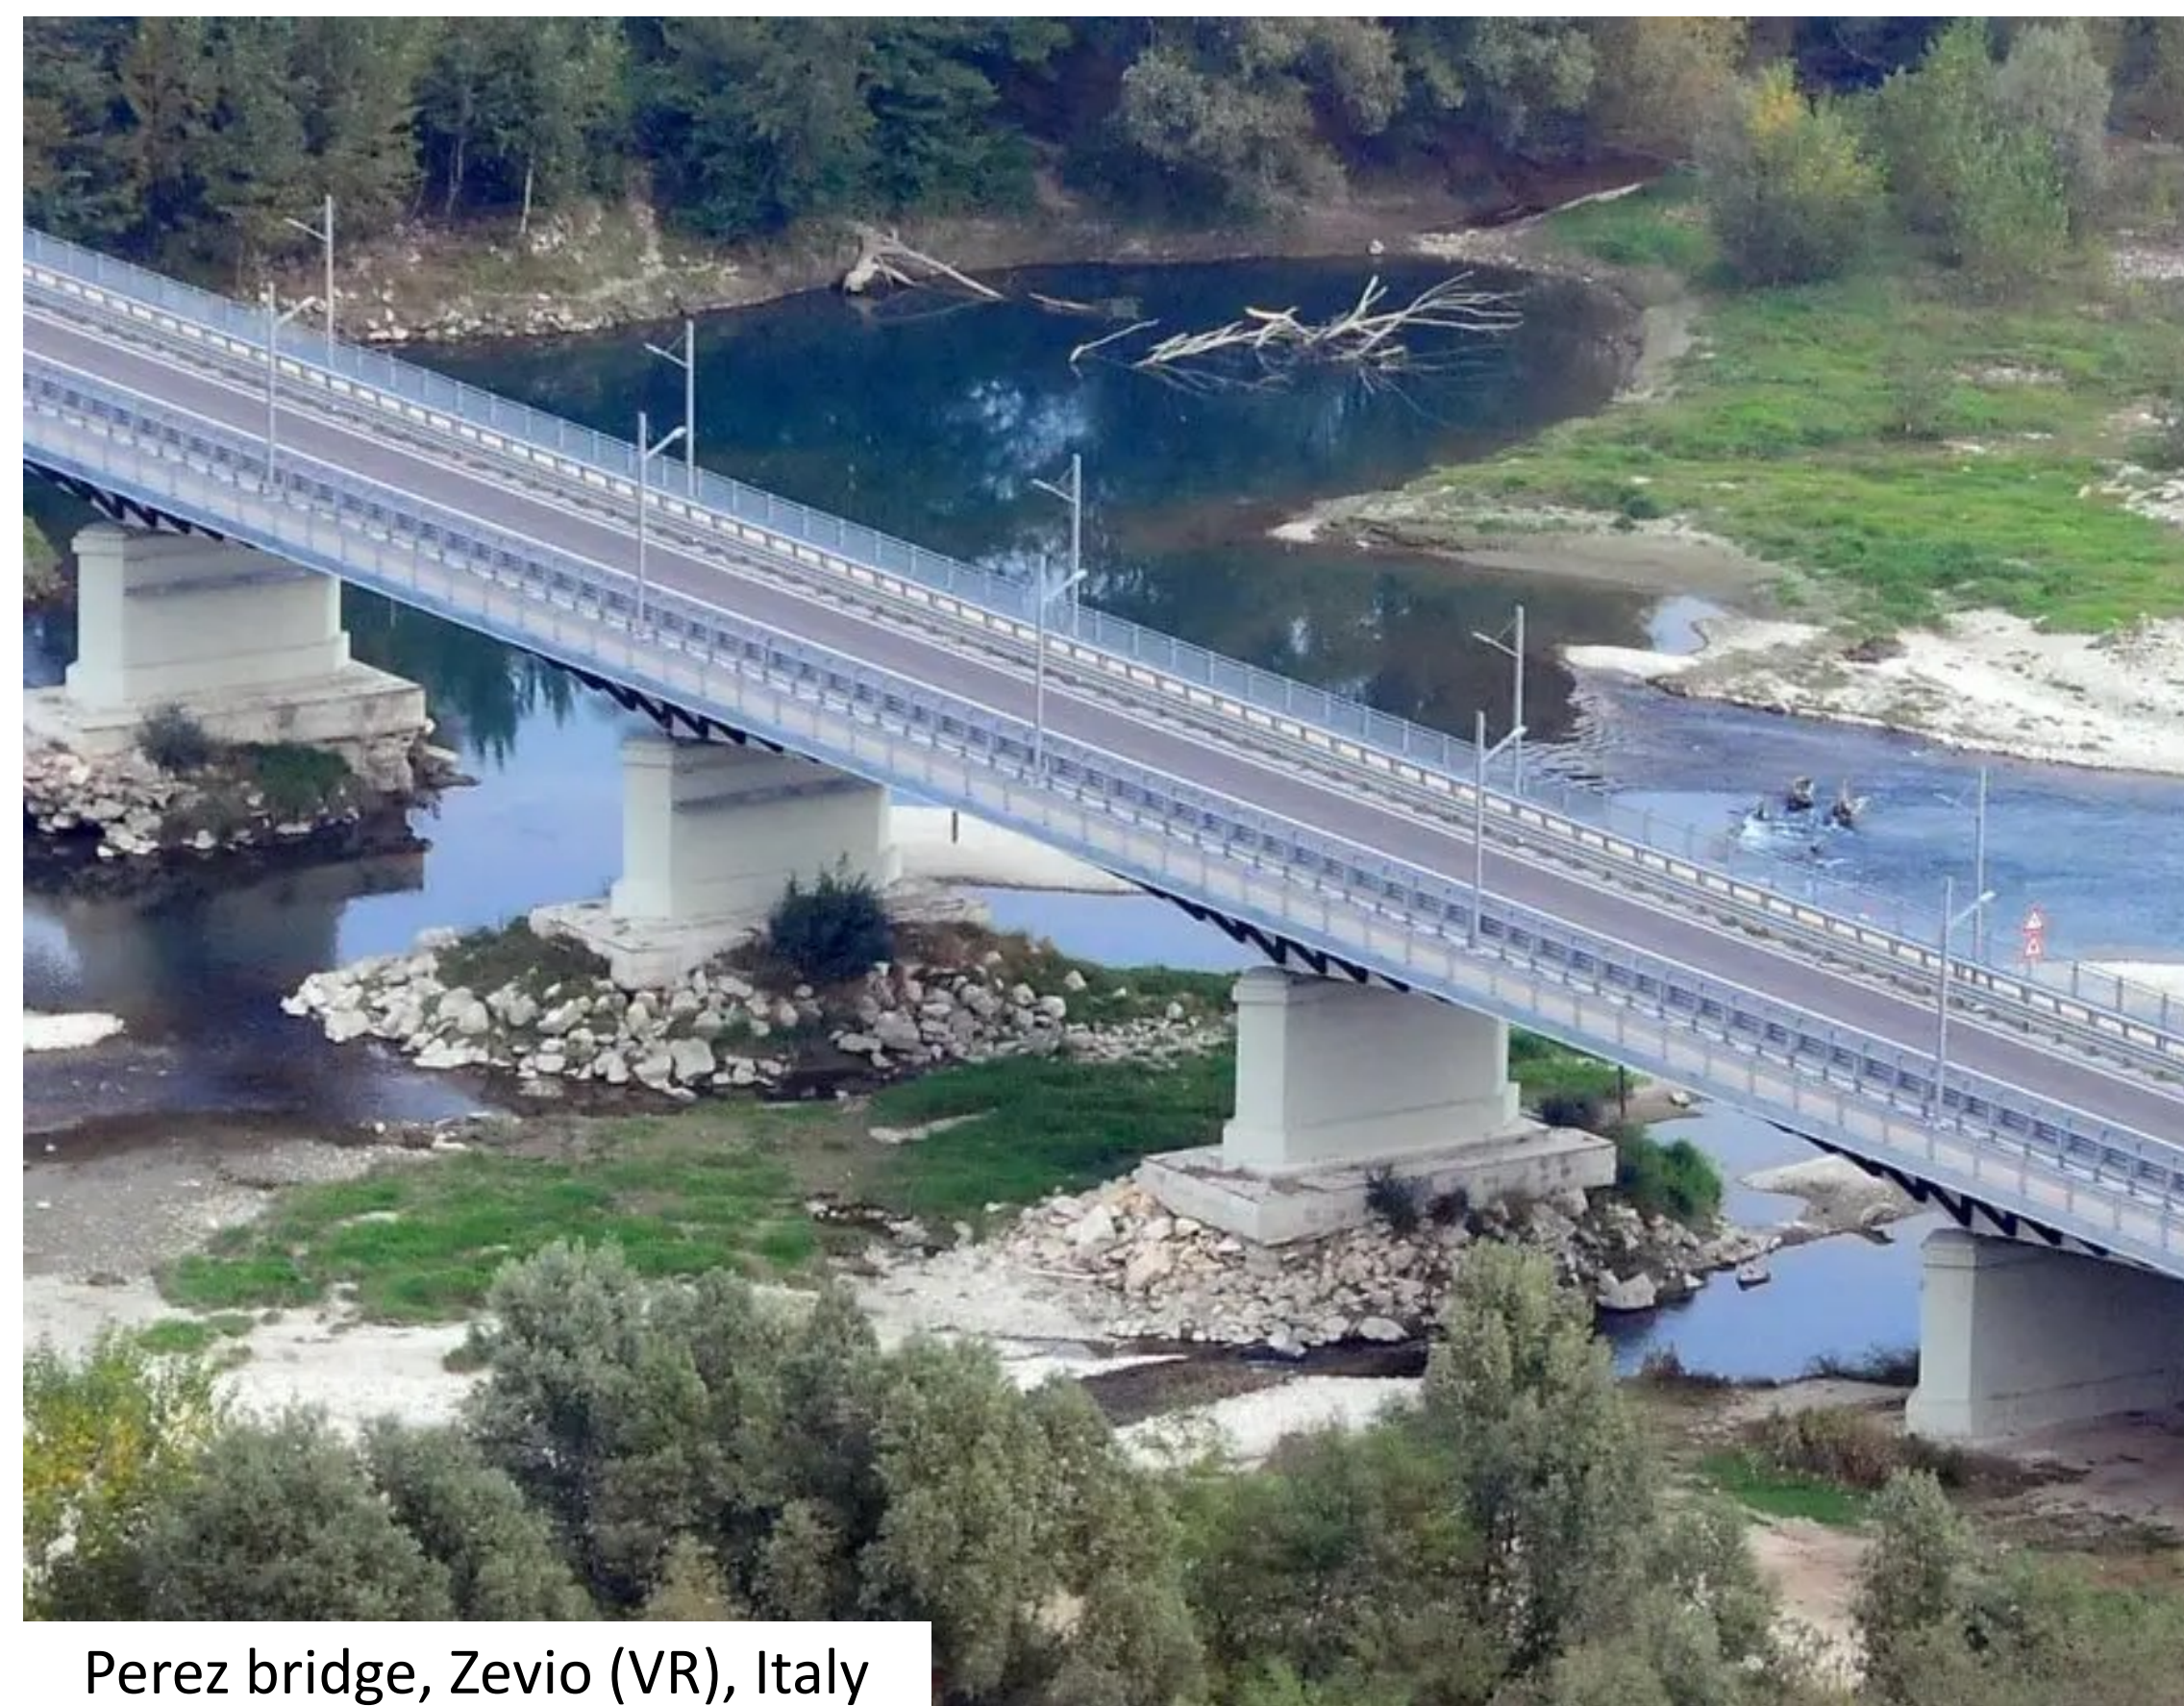
Perez bridge, Zevio (VR), Italy

Among existing infrastructures, the foundations of piers and abutments are characterized by limited depth, also due to the technology available in the past. Nevertheless, old bridges are still working thanks to the ancient custom of filling any recognized scour around piers and abutments with **launchable stones** after each relevant flood event. Now, **riprap mattresses** are sometimes adopted as countermeasures instead to assume a proper deepening of foundations.

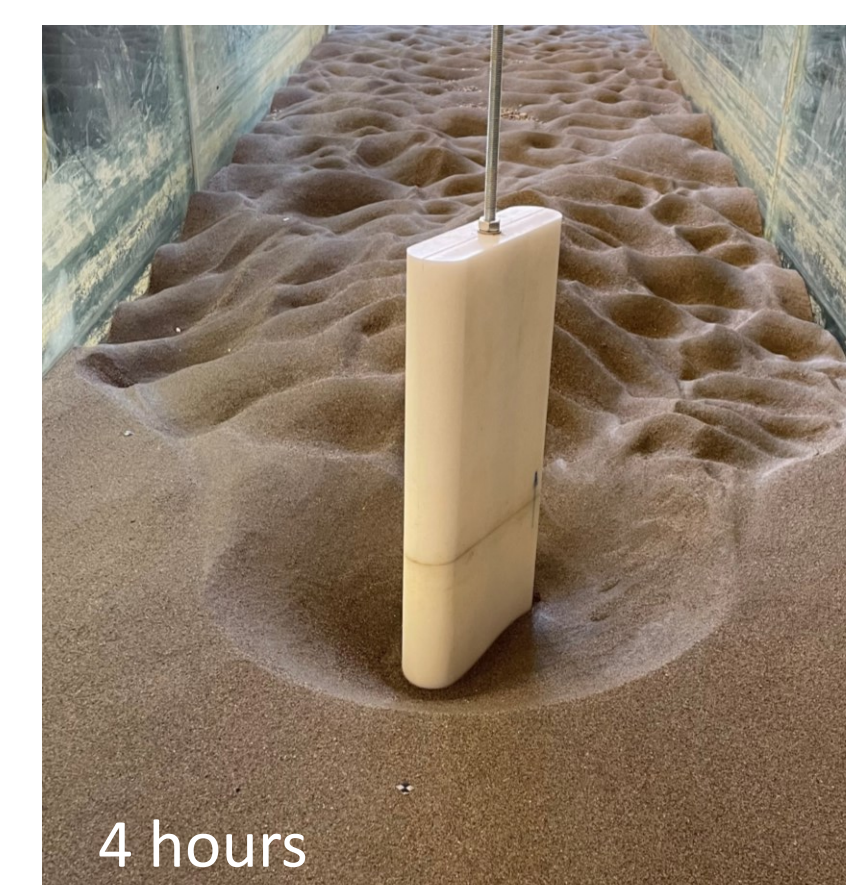
4 hours

### LAUNCHABLE STONES

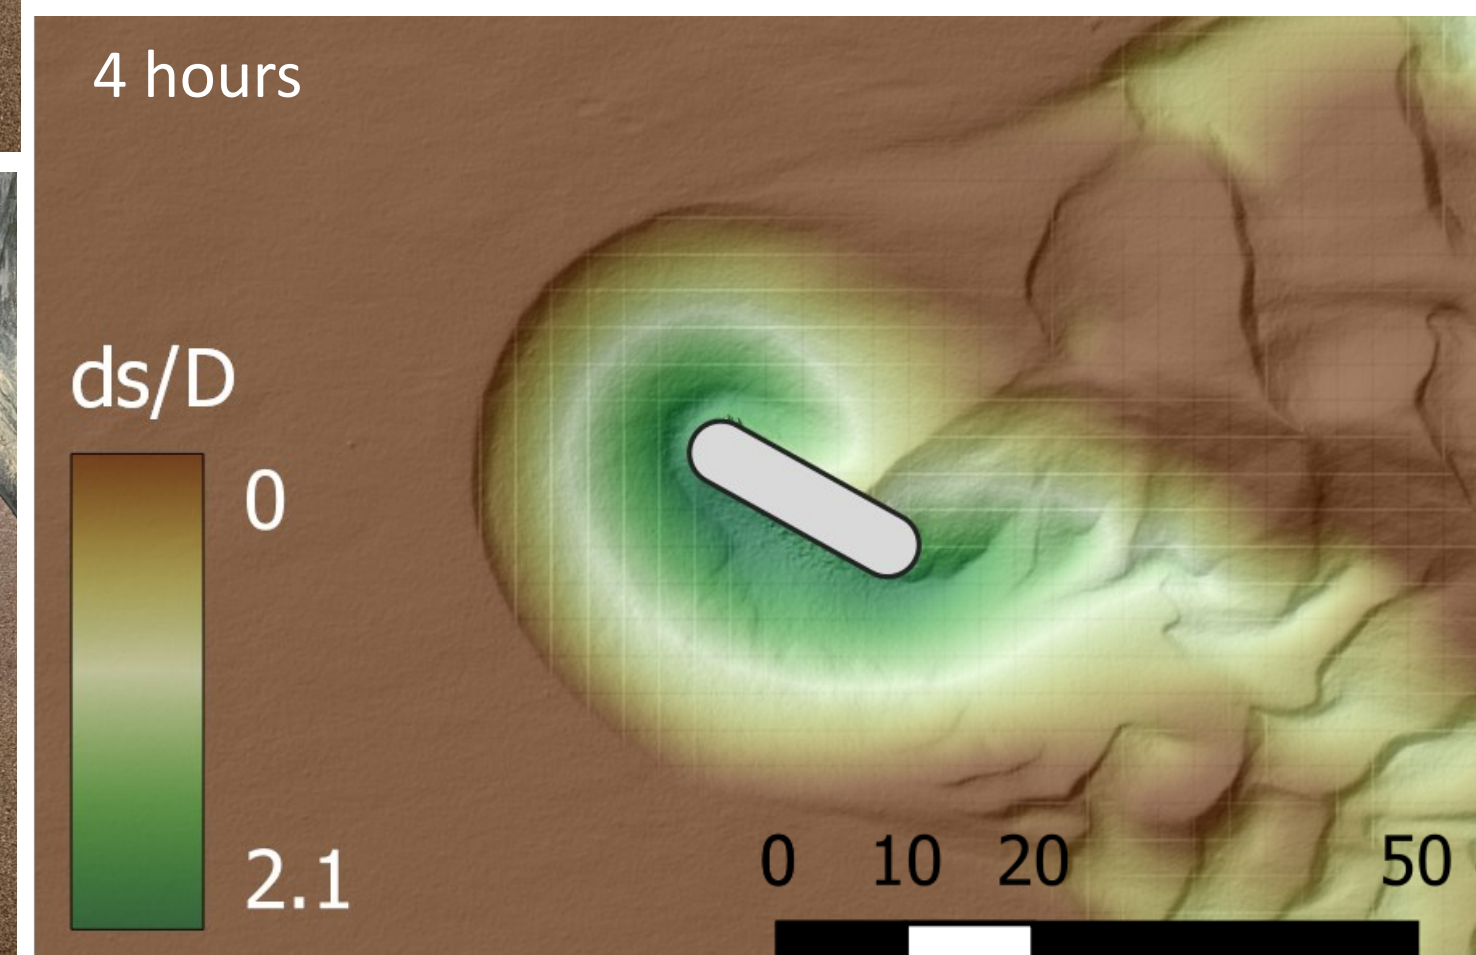
### COST INCREASE

V boulders (prototype) 349 m<sup>3</sup> Nr. dump trucks 32

**LEGEND**  
 ds = max scour depth  
 D = pier width  
 U = flow velocity  
**Elongated pier**  
 5 x 20 cm<sup>2</sup>  
 skew-angle = 30°  
 flow depth = 10 cm  
**Flume**  
 1 m wide and 15 m long  
 U/Uc = 0.90  
 riverbed d<sub>50</sub> = 0.34 mm  
 boulders d<sub>50</sub> = 9 mm  
 geometric scale 1:50

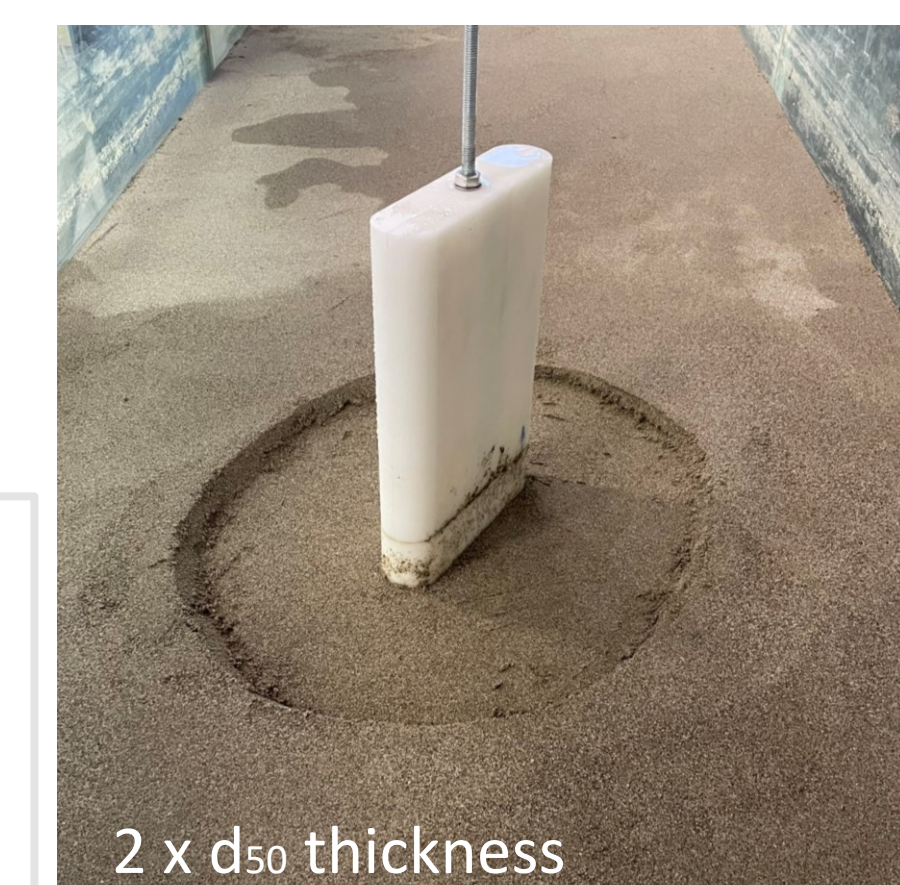
2 x d<sub>50</sub> thickness

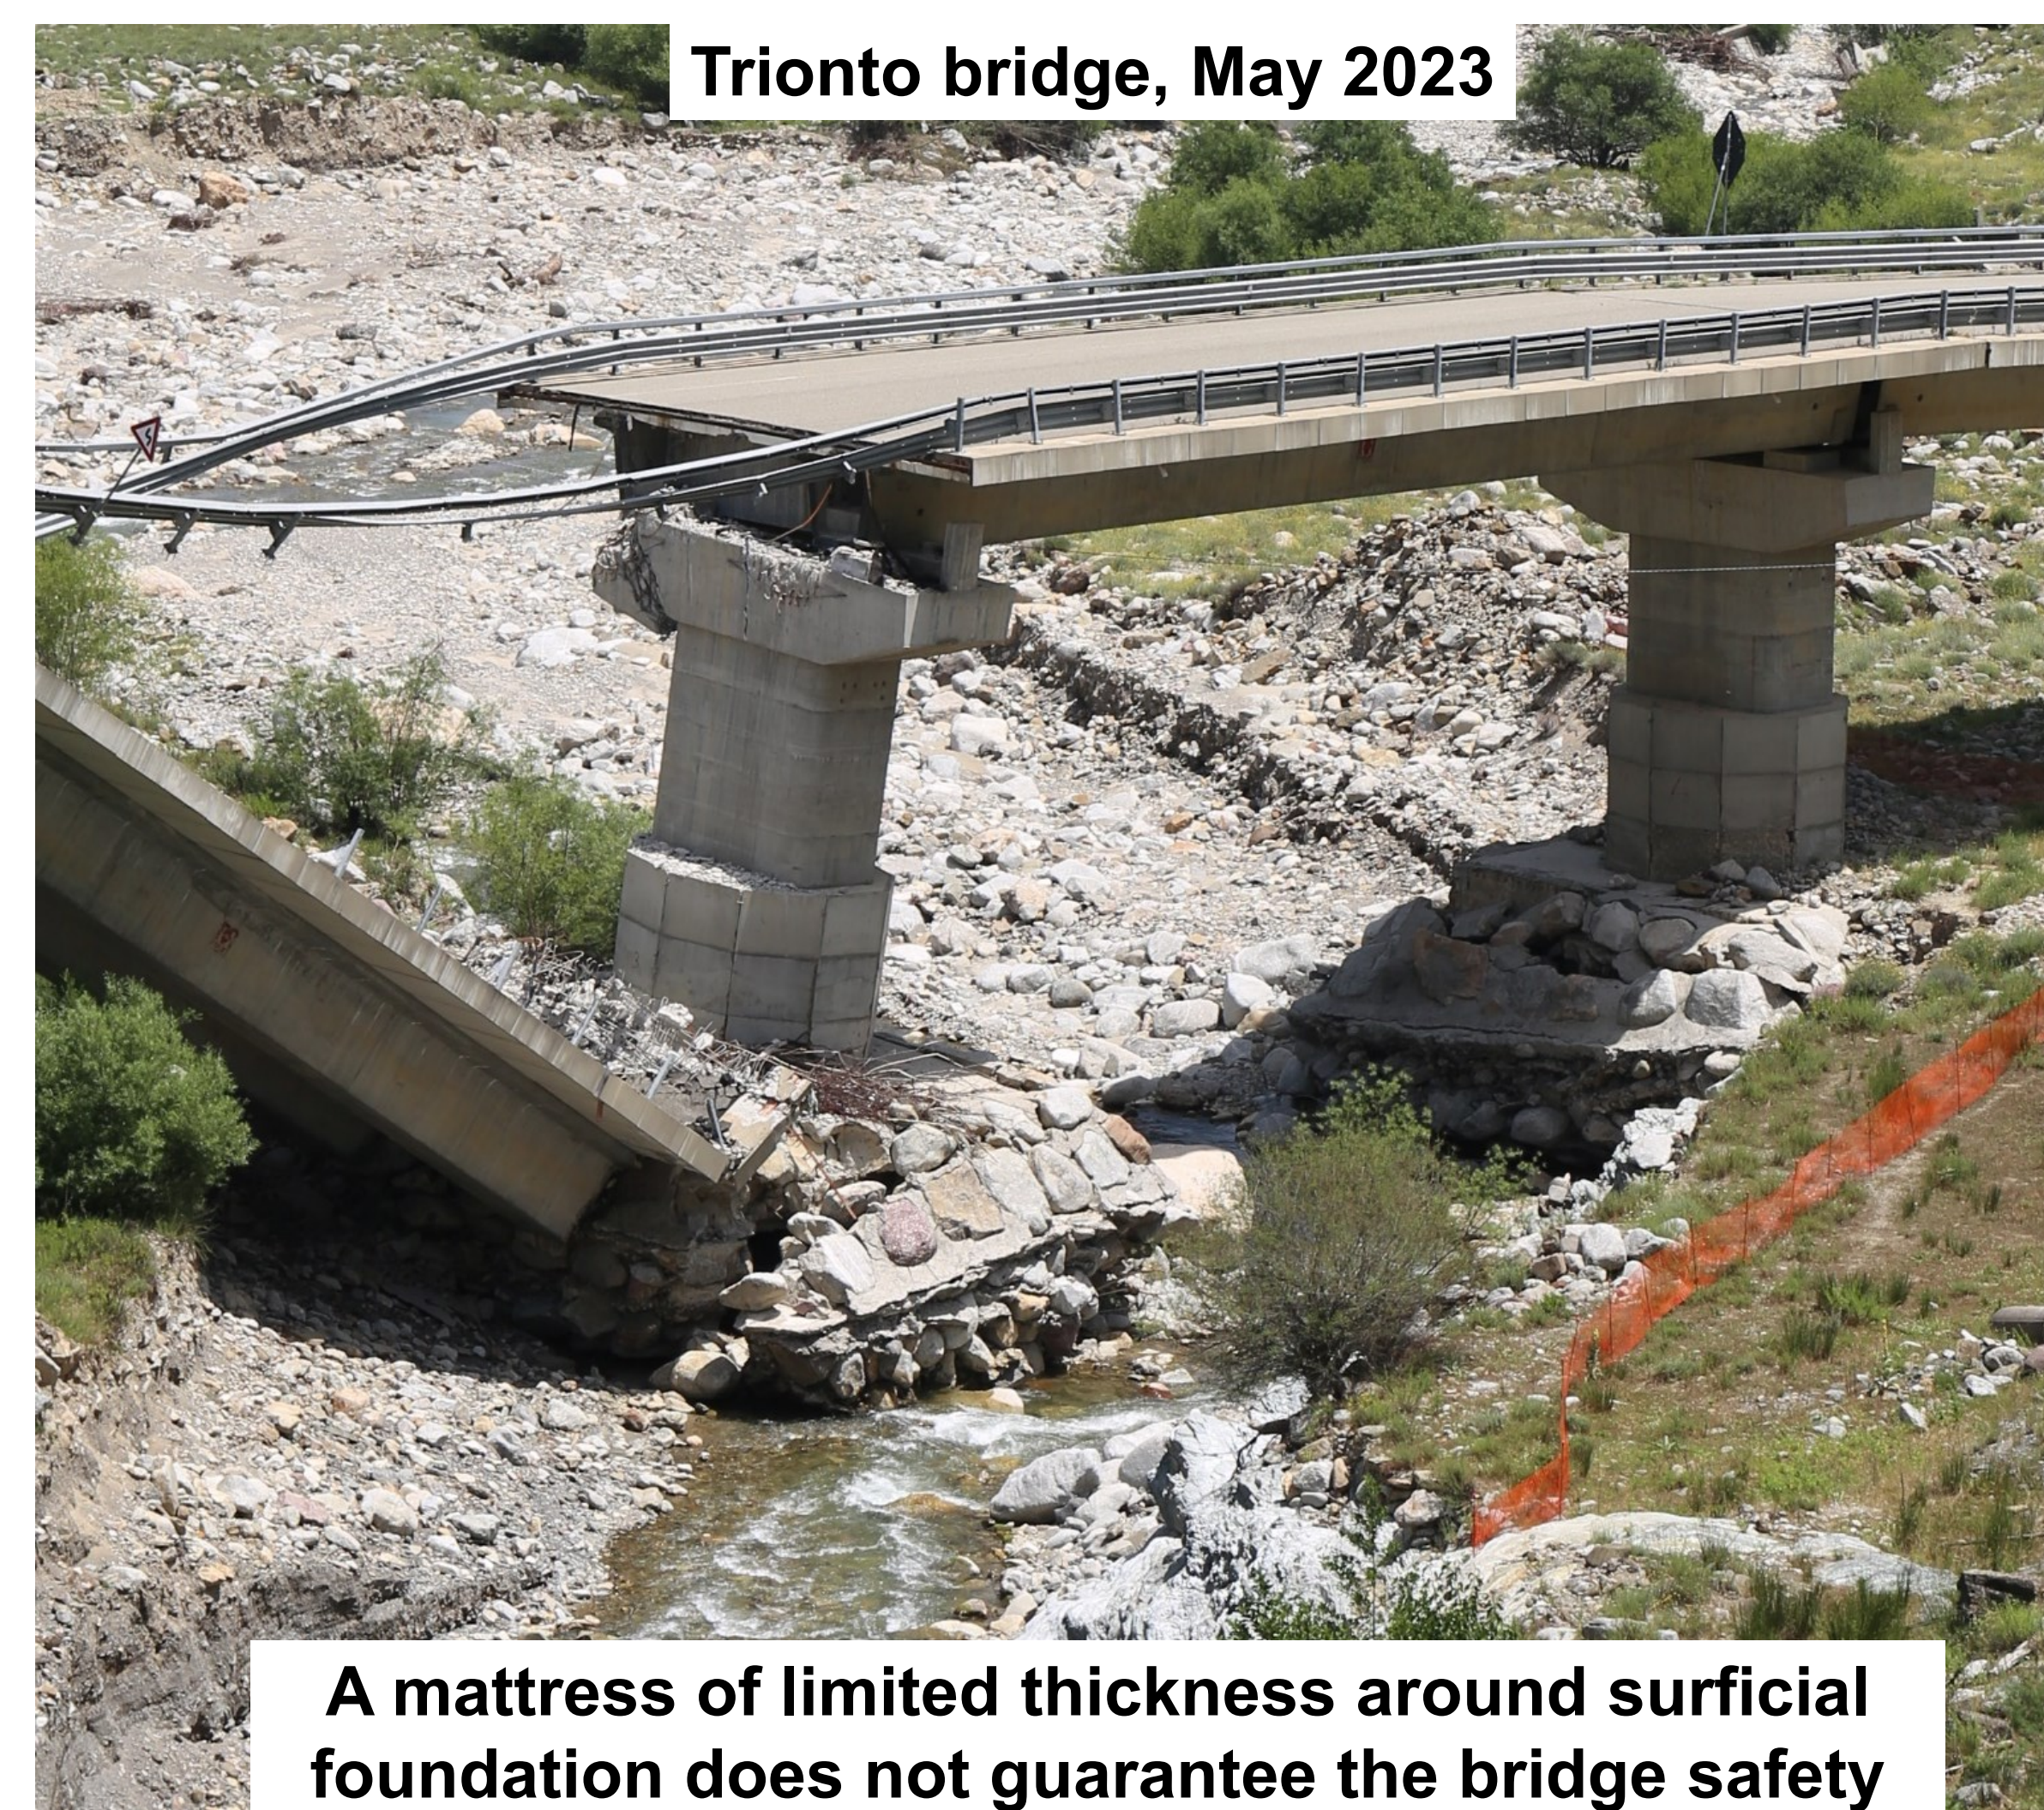
Trionto bridge, May 2023

A mattress of limited thickness around surficial foundation does not guarantee the bridge safety

Stability against localized scour can only be obtained by proper deepening of foundations

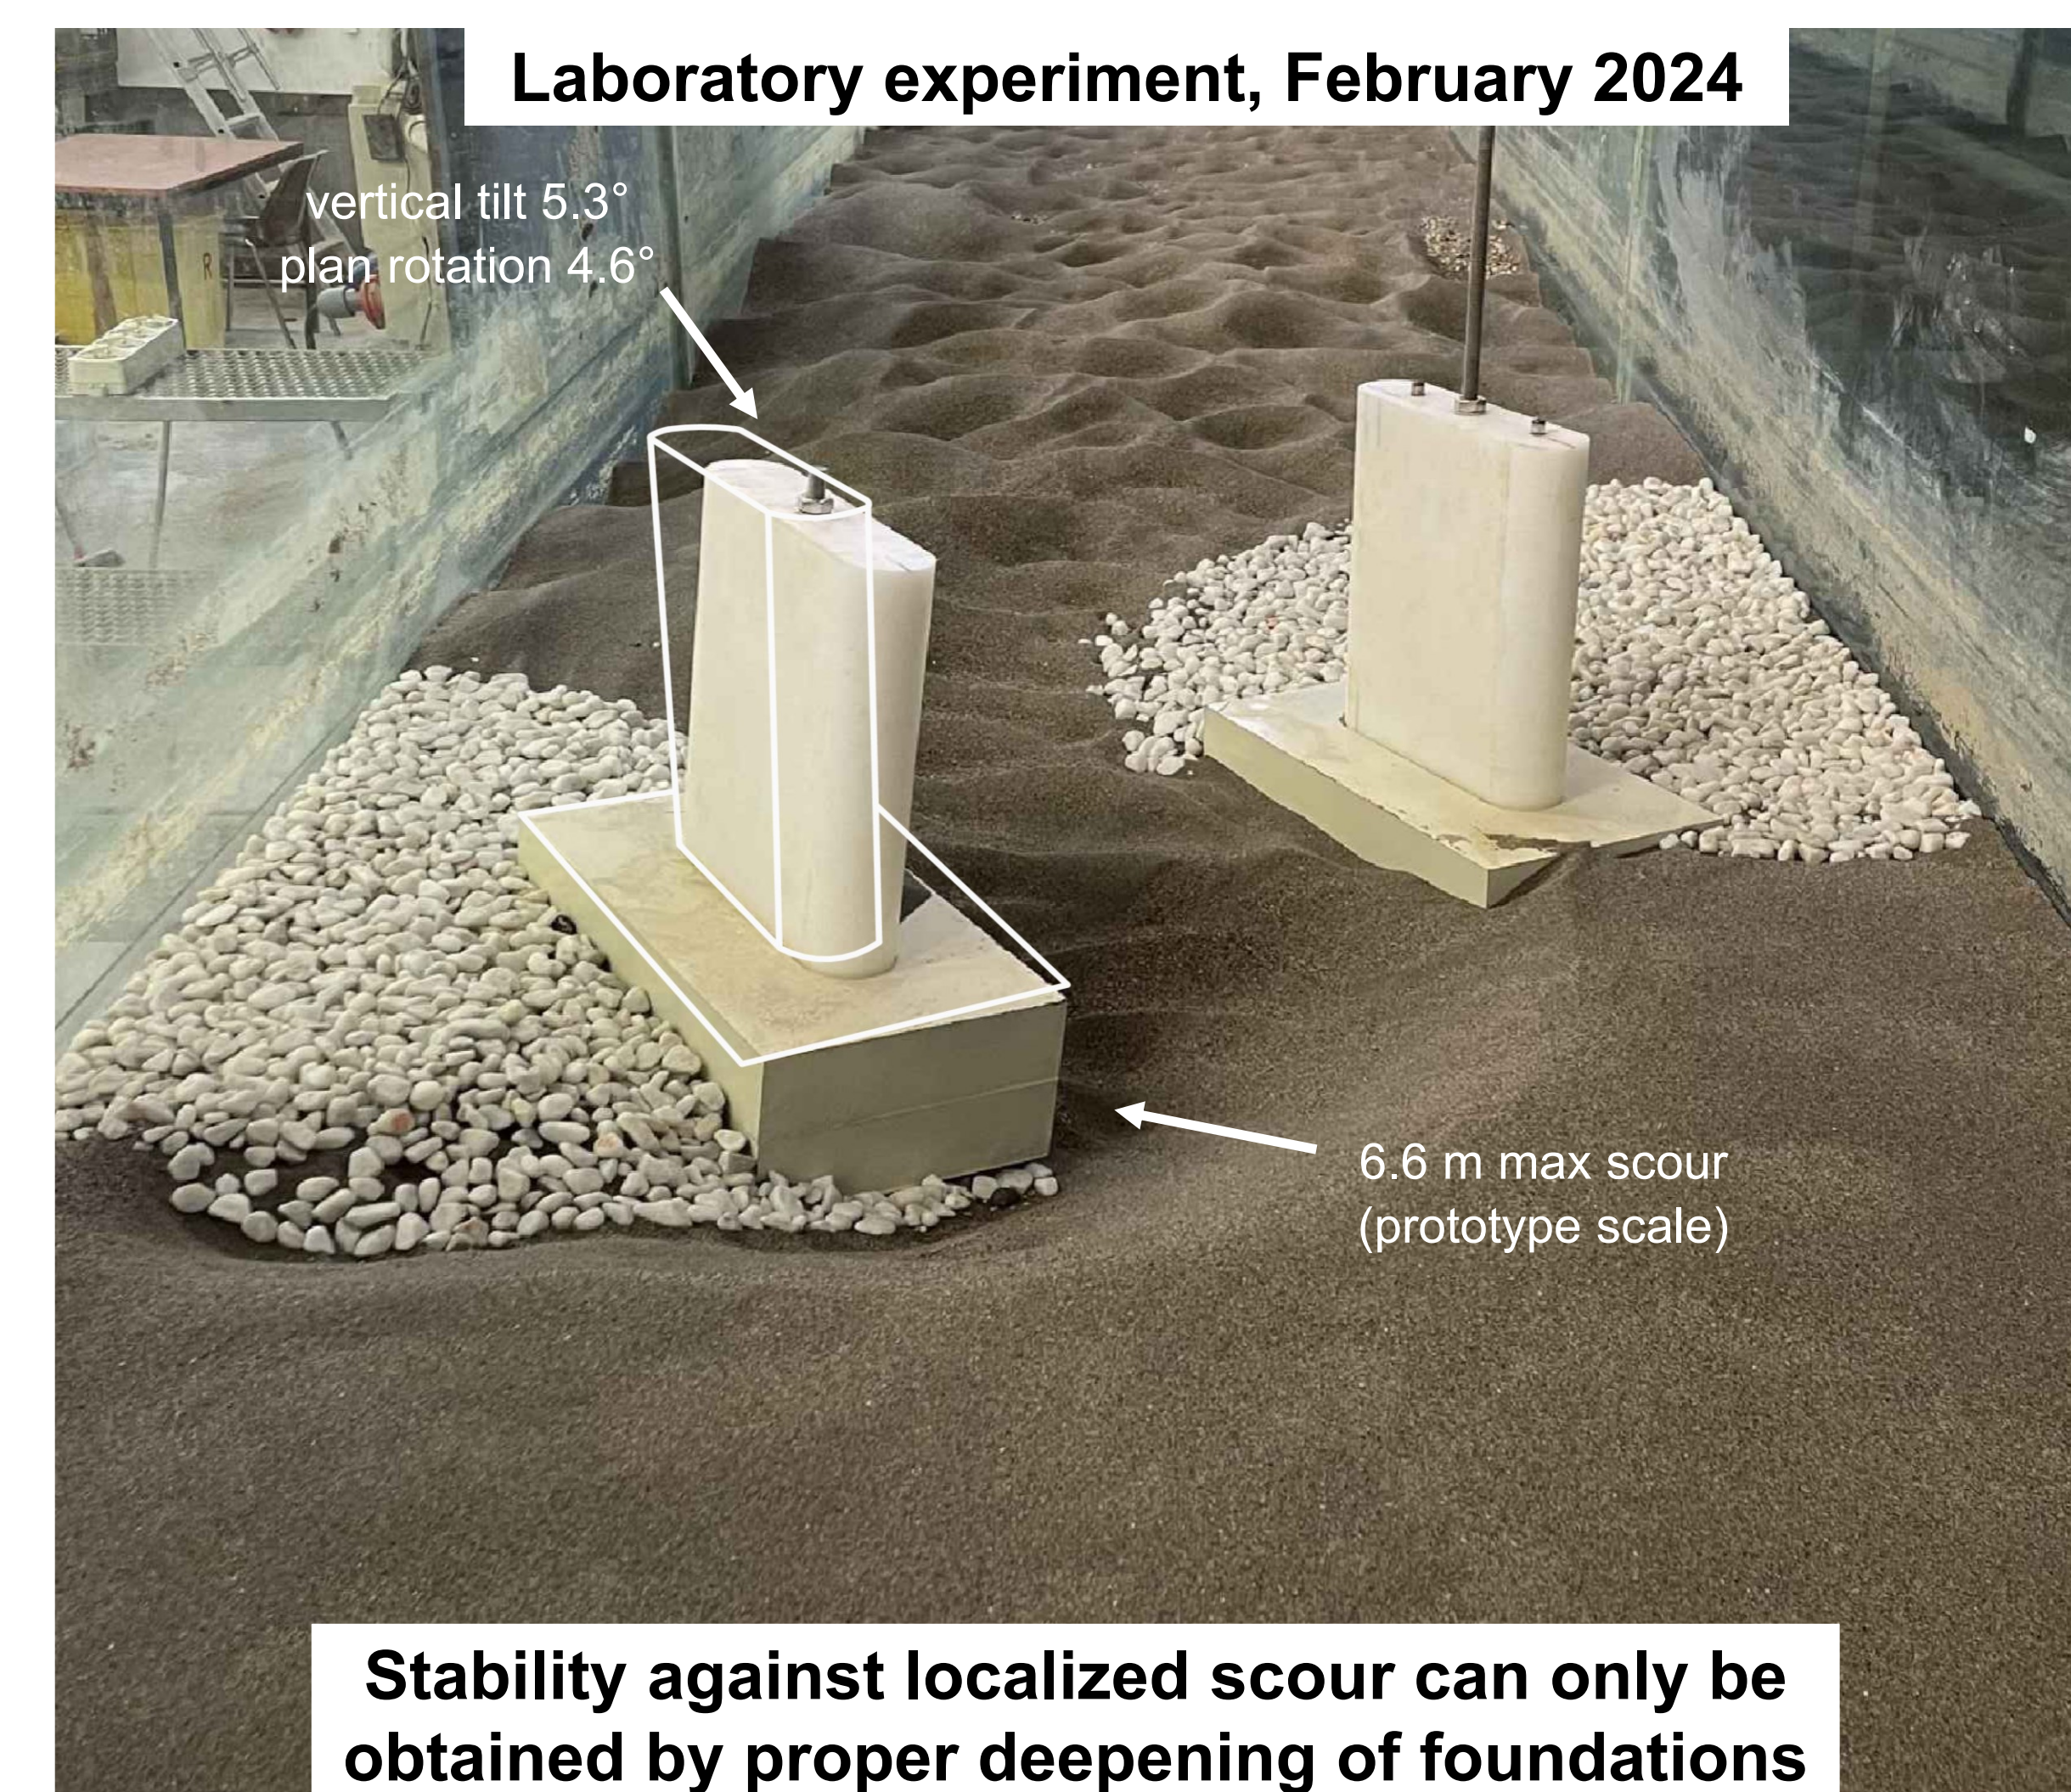
Laboratory experiment, February 2024

vertical tilt 5.3°  
 plan rotation 4.6°

6.6 m max scour (prototype scale)
